39th Avenue Greenway Vibration Monitoring

Week of November 12 to November 16, 2018

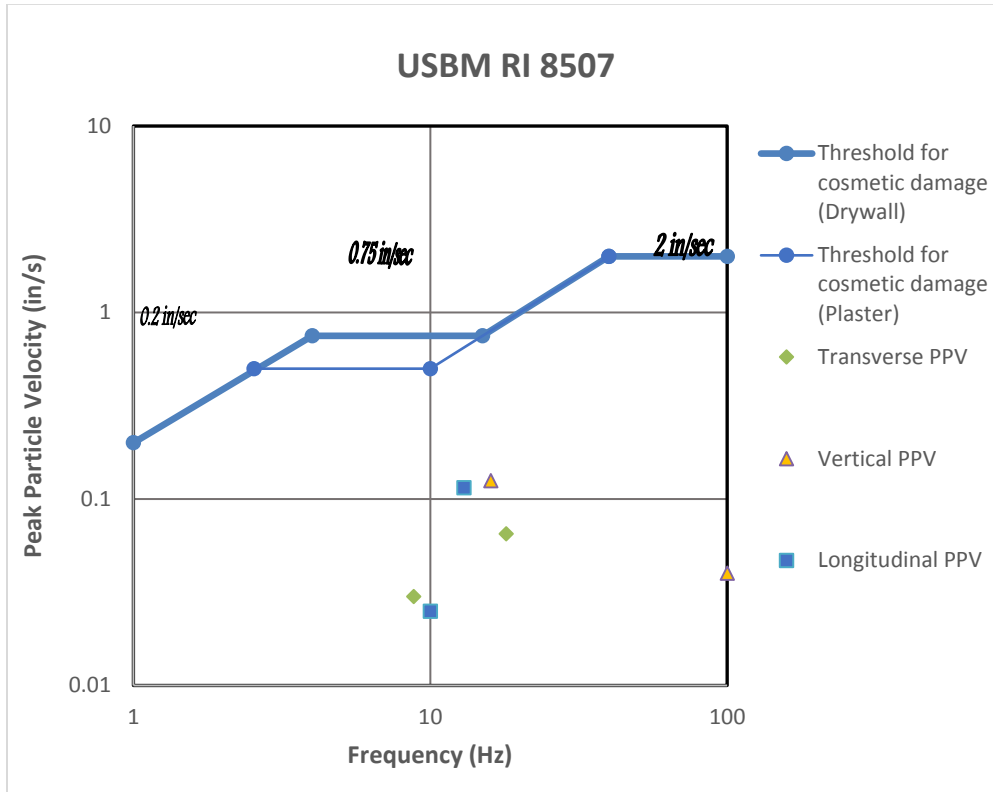
Box Culvert (Zone 3)

Vibration monitoring was performed near the box culvert installation.
