39th Avenue Greenway Vibration Monitoring

Week of November 26 to November 30, 2018

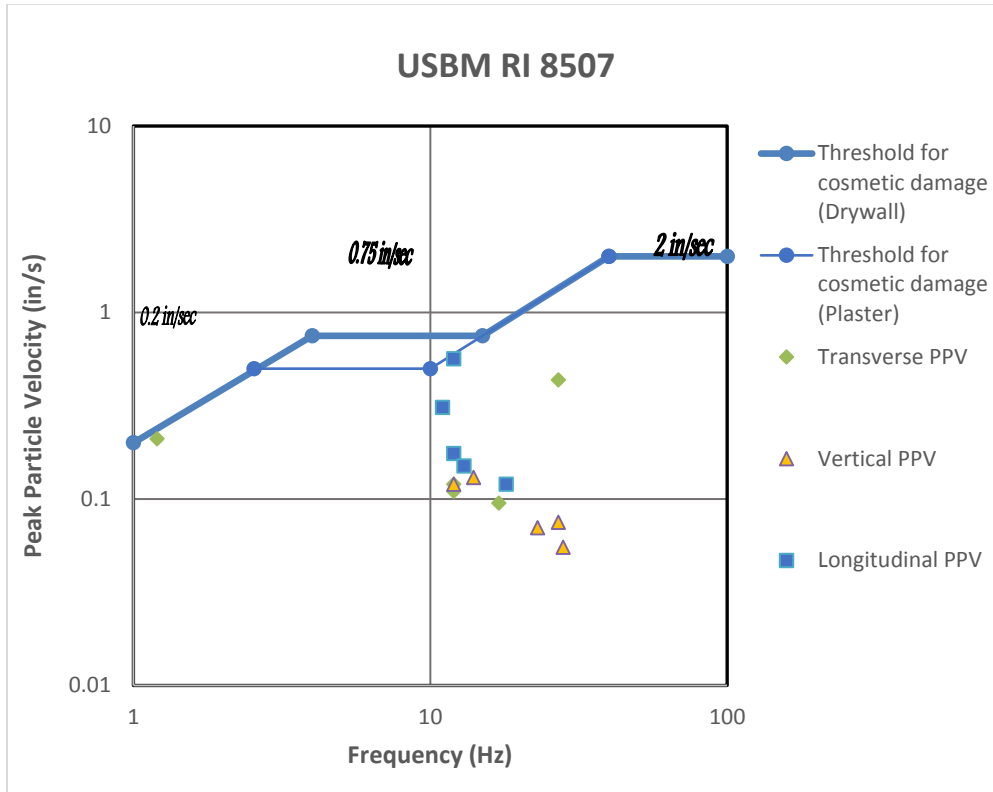
Box Culvert (Zone 3)

Vibration monitoring was performed near the box culvert installation.
