39th Avenue Greenway Vibration Monitoring

Week of December 3 to December 8, 2018

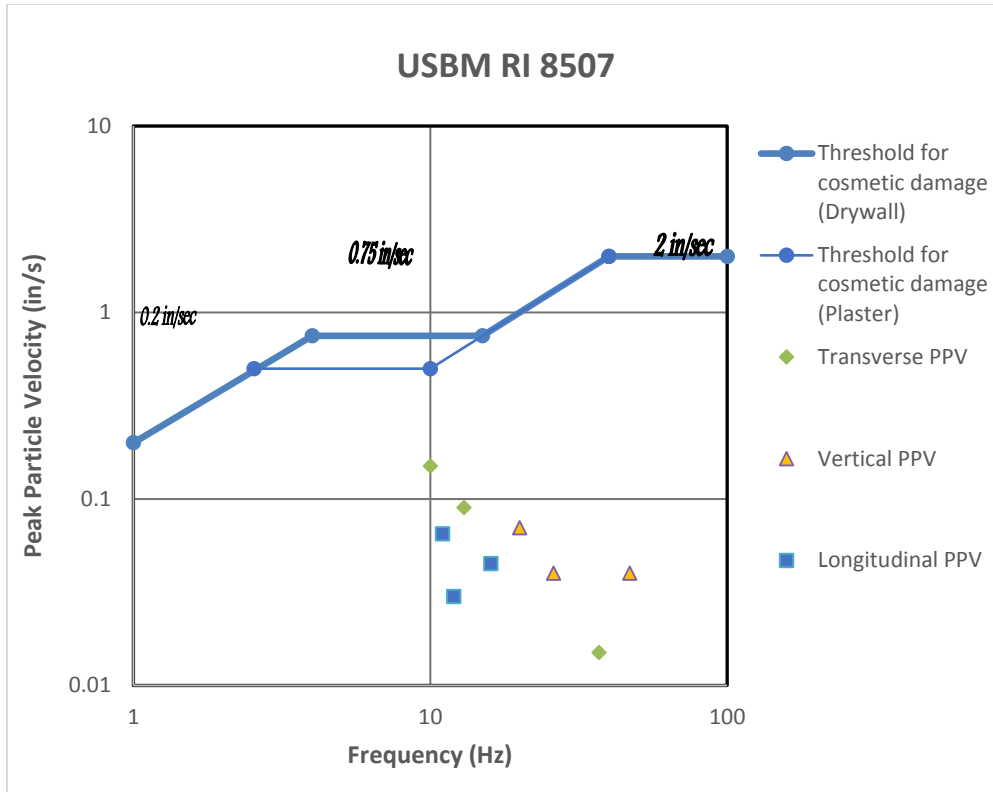
Box Culvert (Zone 3)

Vibration monitoring was performed near the box culvert installation.
