STAFF BRIEF

Project:	#2026-COA-216	LPC Meeting:	March 3, 2026
Address:	2535 W River Dr.	Staff:	Krystal Marquez
Historic Dist/DLM:	River Drive Historic District		
Year structure built:	1888 (Period of Significance: 1885-1923)		
Council District:	#1 – Amanda Sandoval		
Applicant:	Robert Laudick, Homeowner

Replacement of 2 casement windows at the front elevation that were installed without Landmark review and approval. Applicant proposes to keep the front windows as installed with casements with enlarged opening.

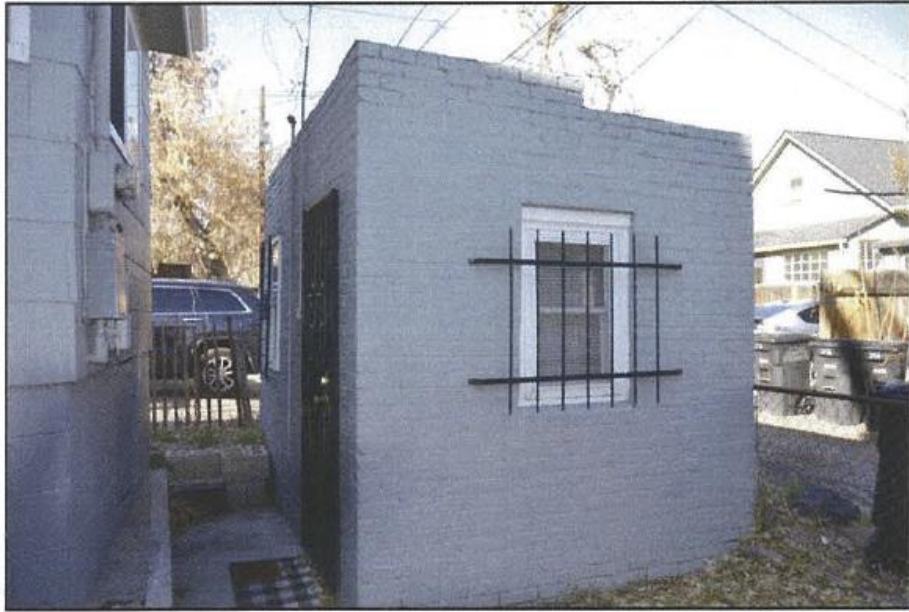
Camera looking northwest at brick coal house
