Aqua Golf Lake

Background, Long Term Issues & Trends

Location: 501 W Florida Ave
Surface Area: 11 acres
Max Depth: ~ 5 ft
Primary Source Water:
South Platte River via Overland Pond; urban runoff
Intended Lake Uses:
Golf driving range; irrigation; wildlife habitat
Current Regulatory Issues^{1/}:
Iron, pH

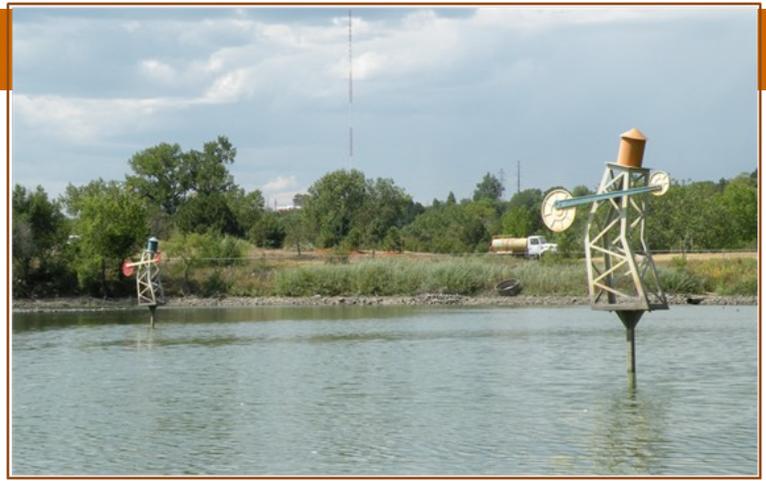
- The shallow depth and poor water exchange throughout the pond create ideal conditions for prolific algae growth (see figure below; chlorophyll-a is an indicator of phytoplankton growth; secchi depth is a measure of water clarity).
- Groundwater flows emanating from the historic Shattuck Superfund site (up-gradient, southeast) historically flowed under the AquaGolf vicinity towards the South Platte River. Groundwater monitoring by the Colorado Department of Public Health and Environment, and surface monitoring by the Denver Department of Environmental Health have found that the Shattuck Superfund site does not pose health risks towards visitors and employees at AquaGolf.
