Barnum Lake

Background, Long Term Issues & Trends

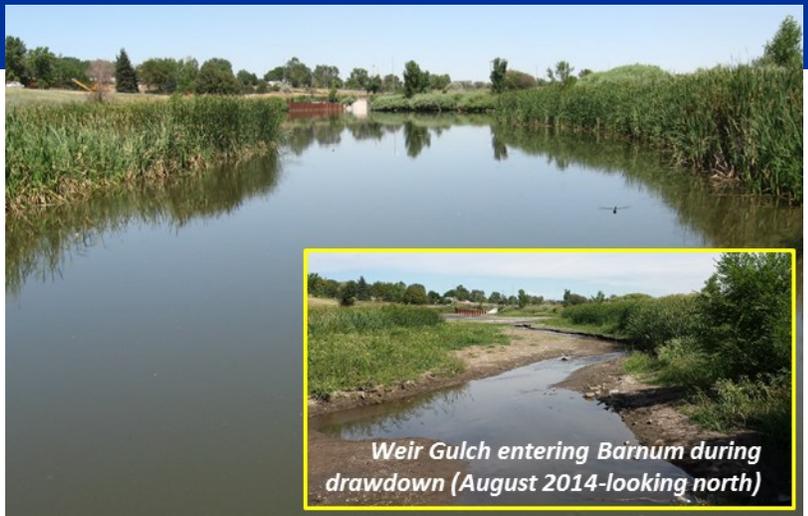
- Barnum Lake is shallow throughout and receives urban runoff via Weir Gulch, which originates in Lakewood.
- Urban runoff is typically high in nutrients (bank erosion, fertilizer runoff from turf management), bacteria, suspended solids, and can have elevated contaminants from paved surfaces.
- In past years the lake has had periodically elevated bacteria (*E. coli*) and low dissolved oxygen. Monitoring data suggests that watershed management efforts have helped mitigate *E. coli* levels (see figure below).

- Determine an effective means to minimize stagnant water in portions of the lake (i.e., mixing, aeration);
- Improve flow at Weir Gulch entry to lake (re-grade lake bed, forebay improvements, longitudinal mixing);
- Assess effectiveness of wetland/forebay complex towards mitigating storm runoff entering from Federal Blvd; and
- Control filamentous algae and vegetation, but not to the extent that planktonic algae (floating algae) will proliferate.
