# Huston Lake

## Background, Long Term Issues, and Trends

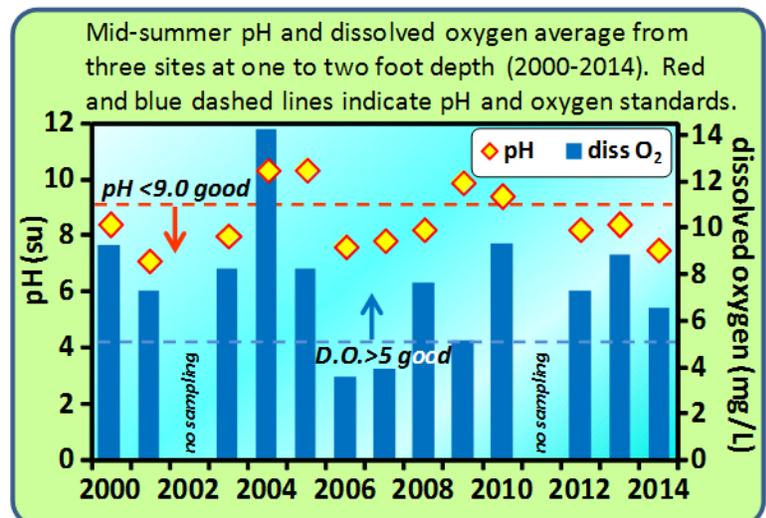
**Water Quality Standards:** Exceedances for **pH** and **dissolved oxygen** (D.O) are attributable to the lake functioning as a wetland (naturally variable pH and oxygen due to plant and algae activity). The pH – D.O. combination have been good the past three years (*see figure below*). A bacteria (*E. coli*) "issue" was attributable to one elevated reading in 2008.

- Establish goals for the lake and manage the vegetation and algae accordingly. If waterfowl habitat is a high priority, allow for rooted vegetation and algae with up to 30% cover so as to sustain food and aquatic insect habitat.
- Increase naturalized landscape around the perimeter to reduce impacts of high maintenance turf grass (i.e., fertilizer).
- Work with the State to develop standards appropriate for wetlands that provide water quality and wildlife benefits (i.e., make allowances for conditions expected in healthy wetlands, such as variable pH and dissolved oxygen).
