Rocky Mountain Lake

Background, Long Term Issues & Trends

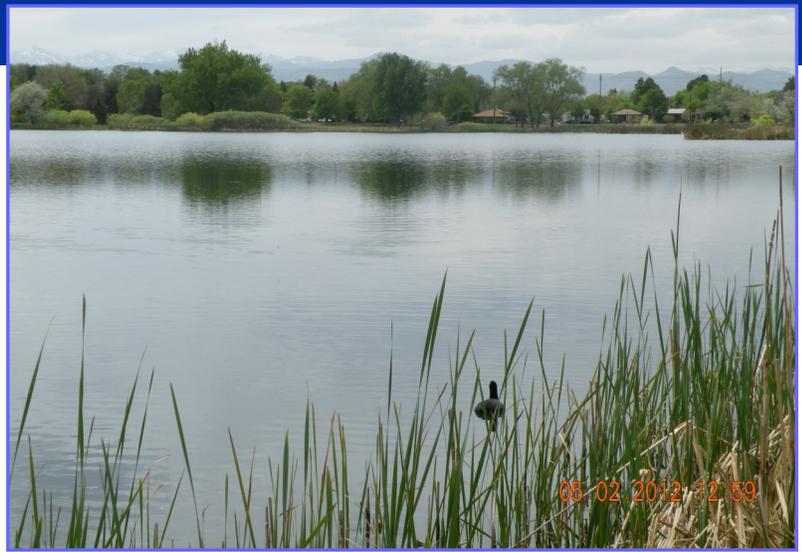
Habitat: There is a diverse and prolific community of rooted plants that is often covered with filamentous algae. This creates ideal habitat for macroinvertebrates (fish food) and fish, but potential issues with dissolved oxygen. However, phytoplankton was the dominant growth form in 2015. This resulted in relatively poor water clarity (as reflected by shallow secchi depth readings) and high pH (see figure to right).
