Sloans Lake

Background, Long Term Issues & Trends

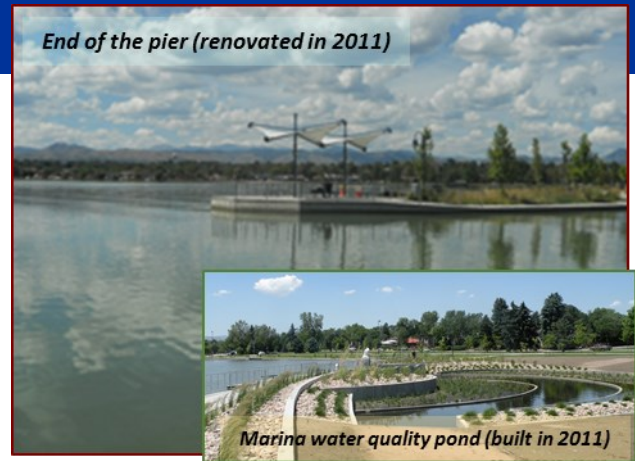
- The expansive wind exposure combined with shallow depths & fine sediments make the lake vulnerable to impacts of re-suspended sediment. These impacts include low water clarity, marginal oxygen, and elevated nutrients and metals (contaminant that are adsorbed to sediment). This is reflected in the relatively high total suspended solids and poor water clarity compared with other Denver Lakes (see figure below).
