# Huston Lake

## Background, Long Term Issues & Trends

Updated April 2019; questions to:

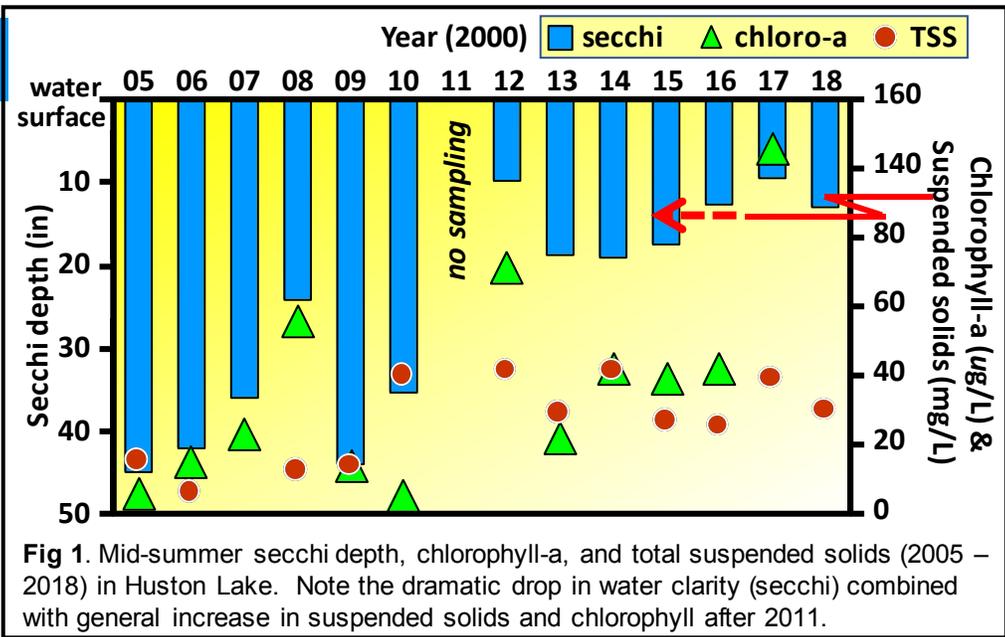
**Fig 1.** Mid-summer secchi depth, chlorophyll-a, and total suspended solids (2005 – 2018) in Huston Lake. Note the dramatic drop in water clarity (secchi) combined with general increase in suspended solids and chlorophyll after 2011.

**Pond Ecosystem:** The lake plant/algae community has been dominated by phytoplankton (floating cellular algae) rather than rooted aquatic plants and the larger filamentous (stringy) algae over the past six to seven years. This greatly deters from habitat for aquatic life (insects, frogs, turtles, and fish), which in turn impacts the value of the lake for a variety of waterfowl and wading birds that rely on aquatic life for food. Water quality is also greatly impacted, resulting in lower water clarity due to elevated phytoplankton and suspended solids (Fig 1).

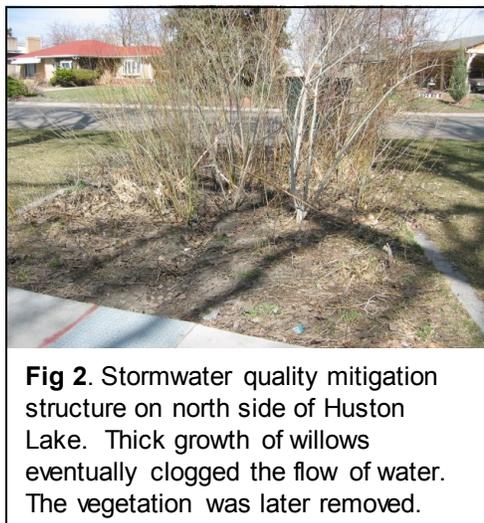
**Fig 2.** Stormwater quality mitigation structure on north side of Huston Lake. Thick growth of willows eventually clogged the flow of water. The vegetation was later removed.

**Urban Runoff Water Quality Mitigation:** The Department of Public Works has built runoff mitigation structures along the north side of the lake in two phases. The first included sand and willow infiltration 'gardens' for the outfalls at Bryant and Alcott Streets (Fig 2). These initially clogged within a couple of years due to excessive growth of the shrubs. After renovating and clearing much of the shrubbery, the structures now provide filtration and settling of contaminants in storm runoff from north of the lake.

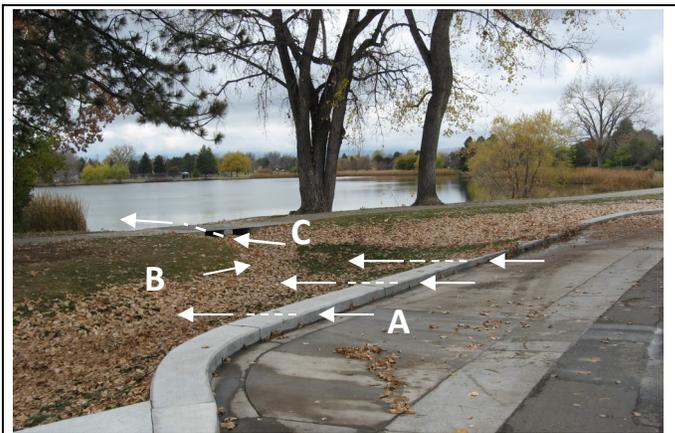
**Fig 3.** Curb-cut stormwater quality mitigation on northeast corner of Huston Lake. Stormwater is initially slowed and detained in the “gutter” (A), then passes through holes in the curb to the swale south of curb (B). What doesn't permeate into the ground and reach the lake via groundwater path, reaches the lake via the undercut beneath the perimeter sidewalk (C).

The second phase was construction of two systems (gutter detention with swale detention/filtration) that discharge water to the northeast corner of the lake (Fig 3). Water then filters through the permeable turf and ultimately reaches the lake without much of the contaminants and trash that were captured prior to hitting the pond.
