# Vanderbilt Lake

## Background, Long Term Issues and Trends

Updated **December 2014**; questions to: [alan.polonsky@denvergov.org](mailto:alan.polonsky@denvergov.org)

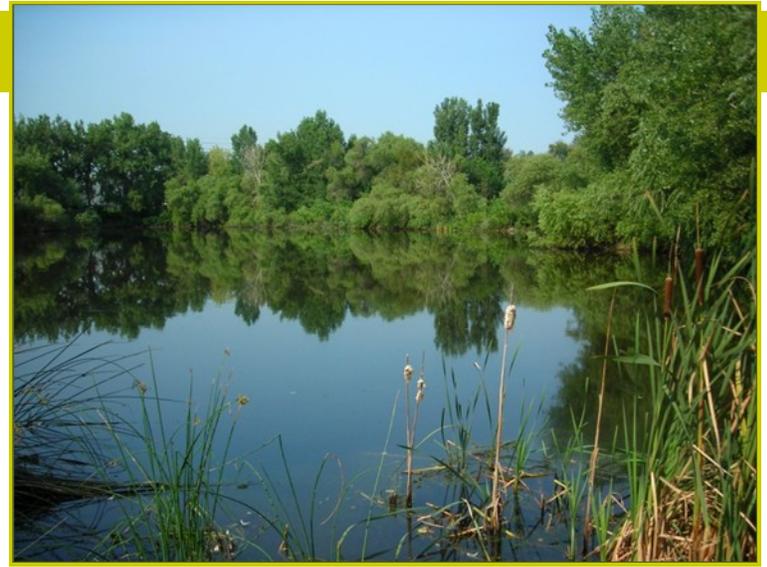
**Ammonia:** Water column ammonia levels were elevated in 2013, but were considerably lower in 2014, consistent with what had been measured in previous years. This appears to be impacted by variable dissolved oxygen levels (which were low in 2013; *see figure*).
